# CASE STUDY.

## **XPERT WRIST:**

Management of a comminuted volar shear distal radius fracture with multiple intra-articular fragments, using a volar bi-plate mounting

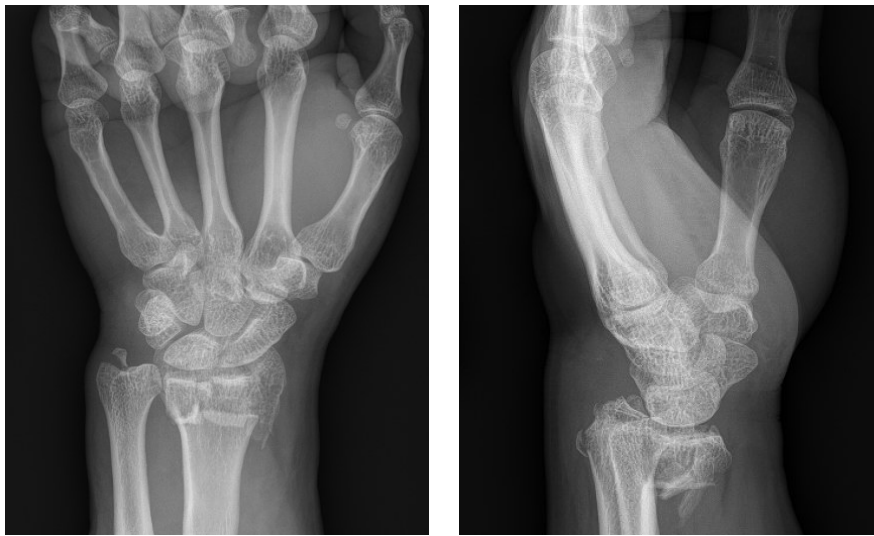
The Preoperative Postero-Anterior and Lateral radiographs demonstrated a comminuted, intra-articular volar shear fracture with multiple intra-articular fragments, including a large radial styloid fragment, a die-punch fragment, and a small volar fragment of the lunate facet.

*Pre-op X-rays*

First, this comminuted fracture morphology does not allow for a traditional volar locking plate proximal to the watershed line, as the distal fragments would be at risk for displacement. Secondly, although a volar rim plate could be considered, a single plate would not properly address all fracture fragments, and would be less than ideal for restoring anatomic alignment of the volar ulna, die-punch and radial styloid fragments.

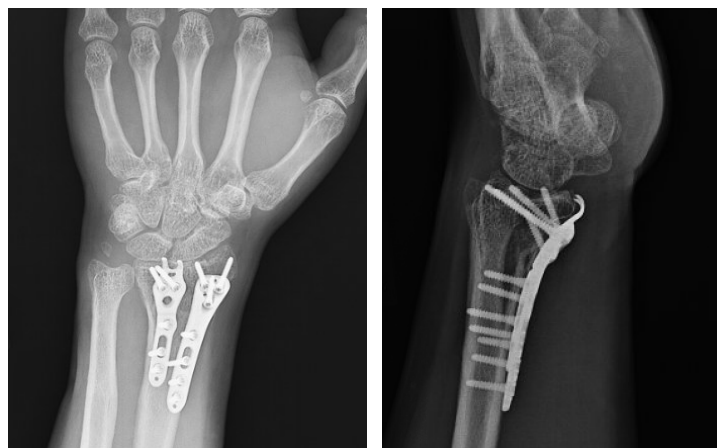
Patient final post-operative visit at 16 weeks post-op showed X-rays with healed distal radius fracture. Measurable motion demonstrated no deficits in pronation/supination, with approximately 80% of flexion and extension compared to the contralateral side.

*16 weeks post-op X-rays*
